Troubleshooting: Perforated Plate Hits the Nozzle

<https://support.zortrax.com/troubleshooting-perforated-plate/>

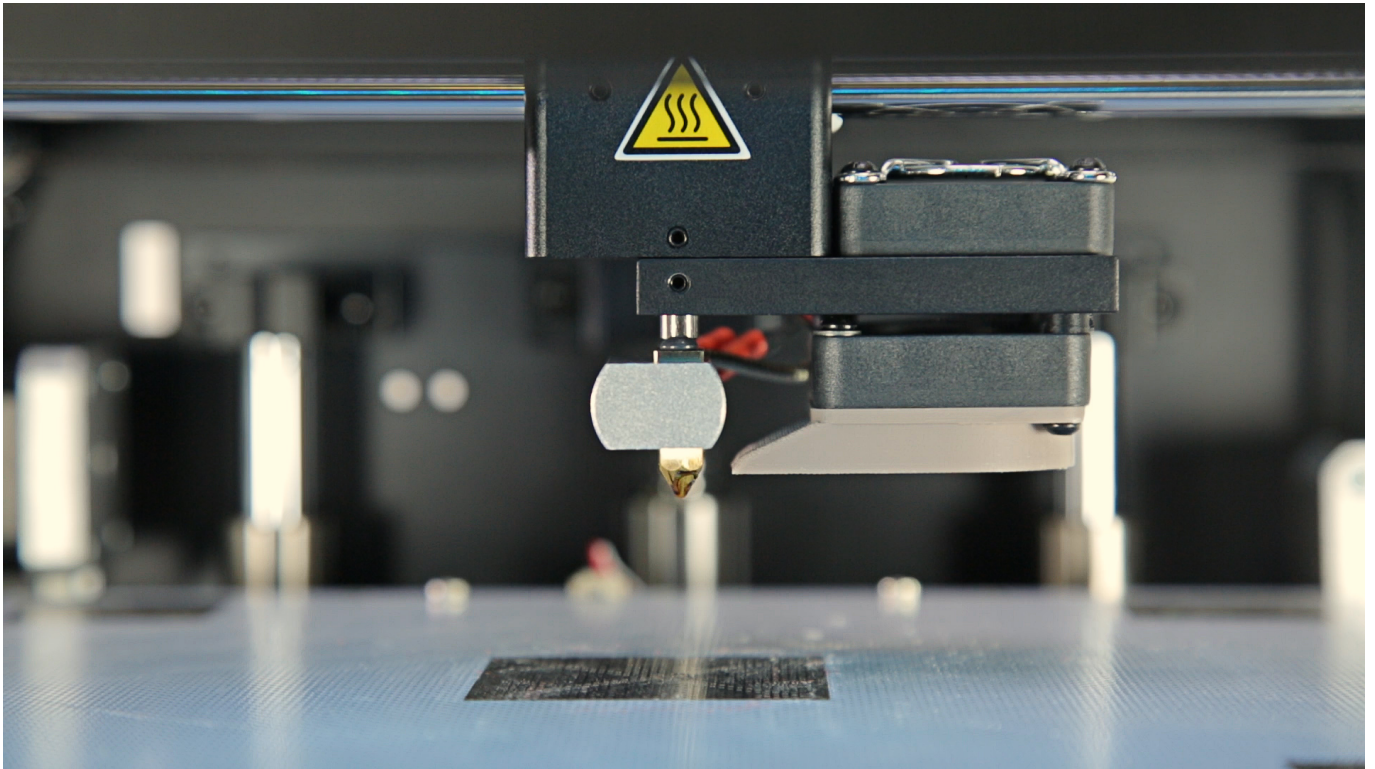
Perforated Plate Hits the Nozzle

The video shows what the problem looks like.

Sometimes the electrical circuit in the printer cannot be completed due to material remains on the nozzle or the perforated plate.

Remember that once the perforated plate in your printer hits the nozzle, immediately turn the printer off with the switch on the left side of the machine.

In this case, clean both parts with a spatula. See the manuals: [nozzle cleaning](#), [platform maintenance \[M200 Plus\]](#), [platform maintenance \[M200\]](#).

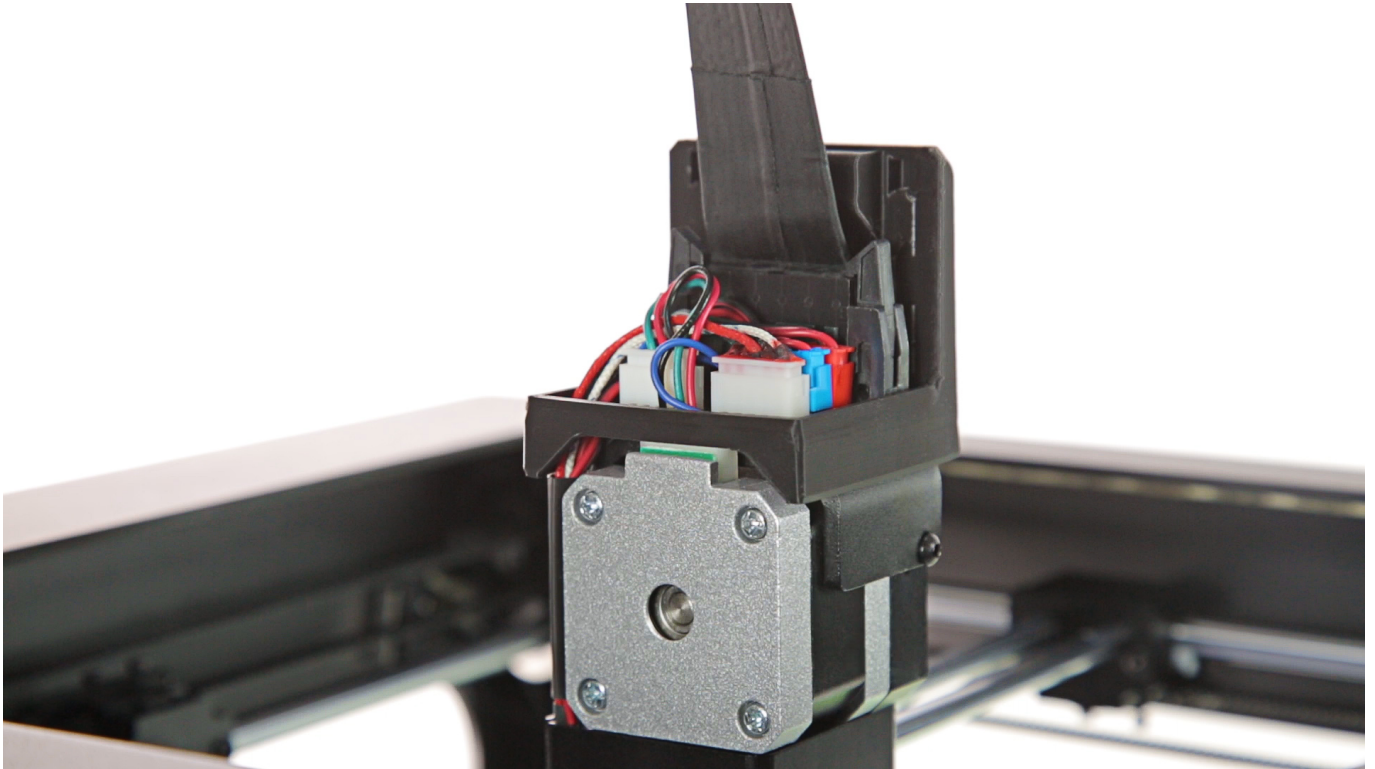
Heater&Thermocouple Connection

In some cases, problems with calibration can occur when the heater&thermocouple connector has not been properly plugged into the extruder PCB.

Detach the extruder upper printed cover from the extruder and check the heater&thermocouple connection.

Also, make sure that the heater&thermocouple are properly installed in the hotend.

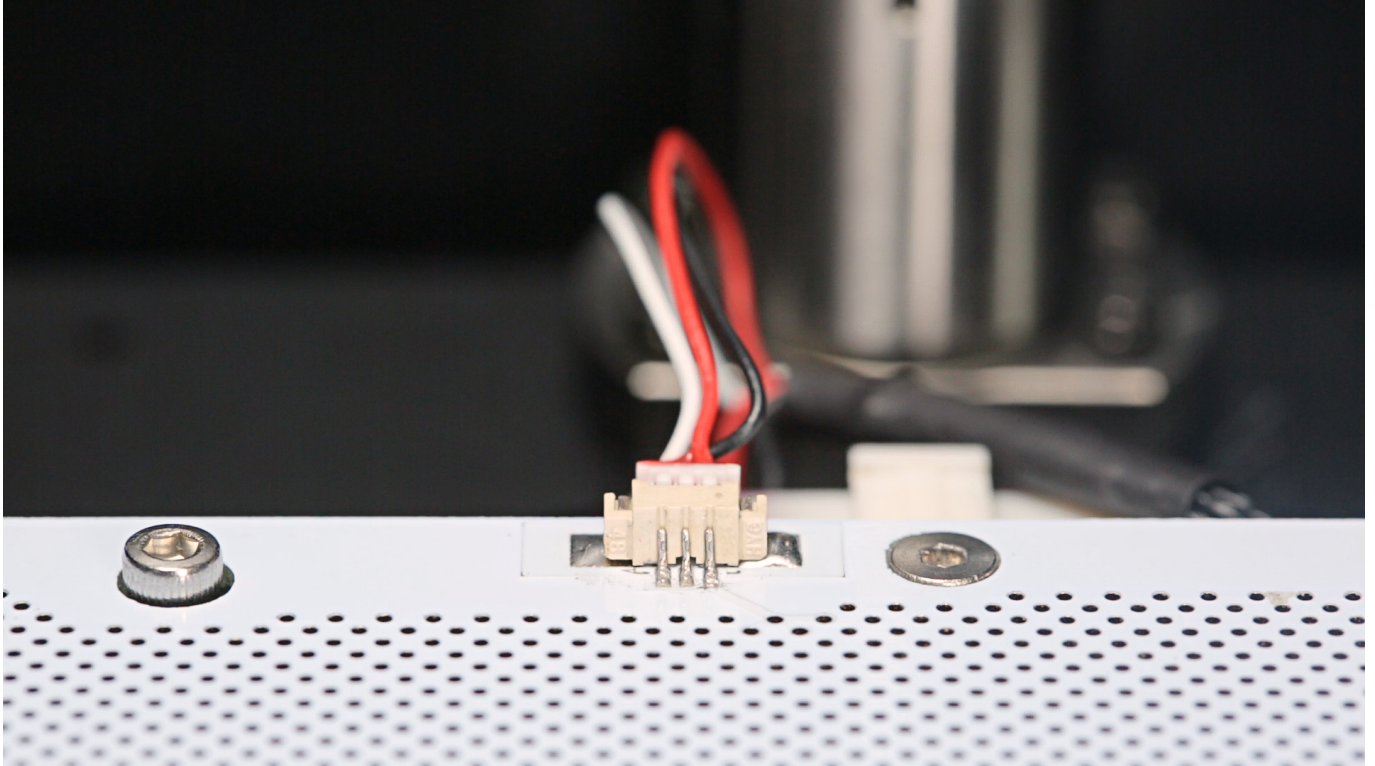
LEFT AND MIDDLE PIN

The next step is to check if the problem is not caused by a perforated plate or heatbed cable failure.

To determine that, prepare a multimeter and measure the electric circuit continuity between the left and the middle pin on the perforated plate's small connector. If the multimeter indicated that there is circuit continuity, follow the next step from this manual.

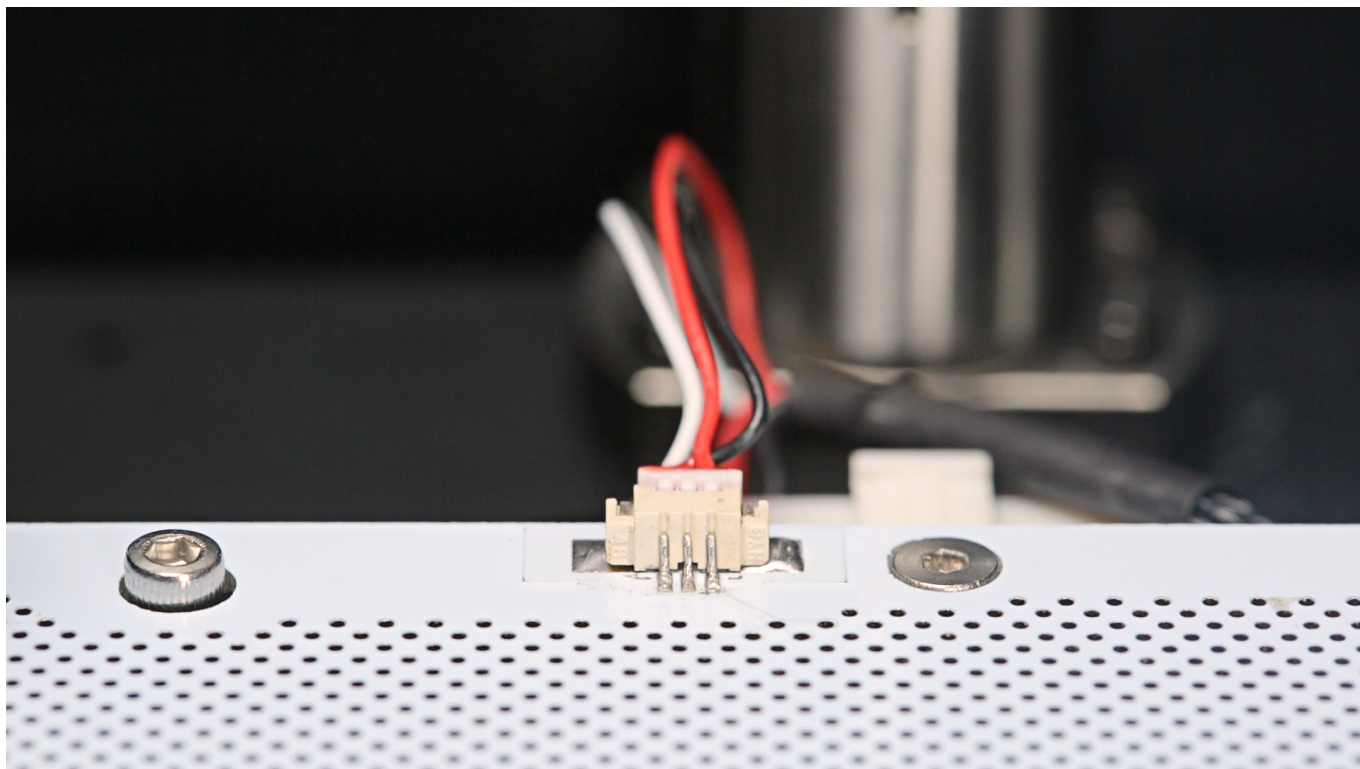
LEFT/MIDDLE AND RIGHT PIN

If the circuit continuity is detected while the platform is unplugged, the problem is caused by the perforated plate failure, and when the continuity is not detected, the problem results from the heatbed cable failure.

Use the multimeter again and measure the circuit continuity between the left/middle and the right pin on the plate's small connector. If there is continuity between the pins, unplug both cables from the platform and repeat the measurement.

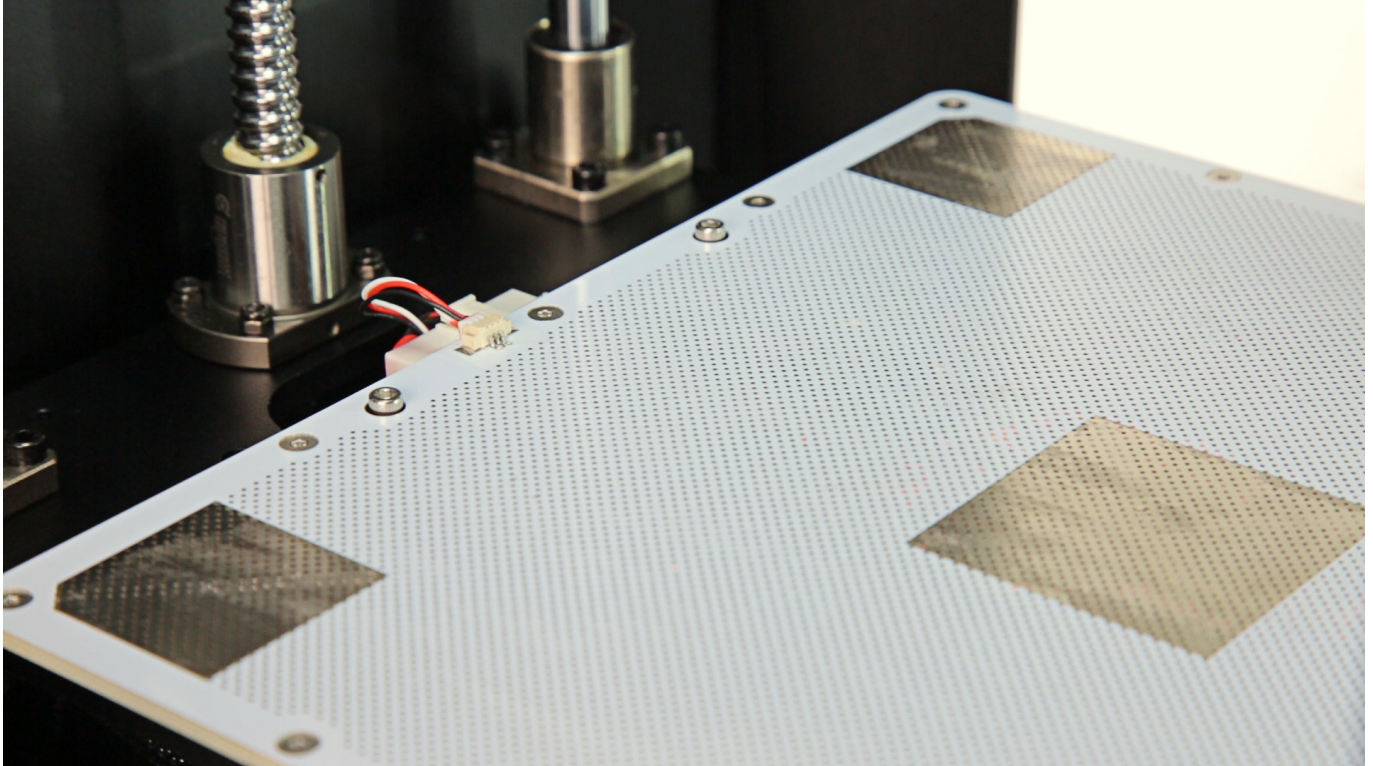
M200/M300/M300 PLUS

The next step is to check if the problem is not caused by the perforated plate. Use the multimeter and measure the voltage between the left and middle pin on the plate's small connector and five calibration squares. The correct value is about 3.2 V.

Make sure that the small connector is not damaged. Otherwise, the voltage might not be properly transmitted to the calibration squares.

If the voltage is lower than 3 V, carry out platform maintenance and check if the underside of the perforated plate is not damaged.

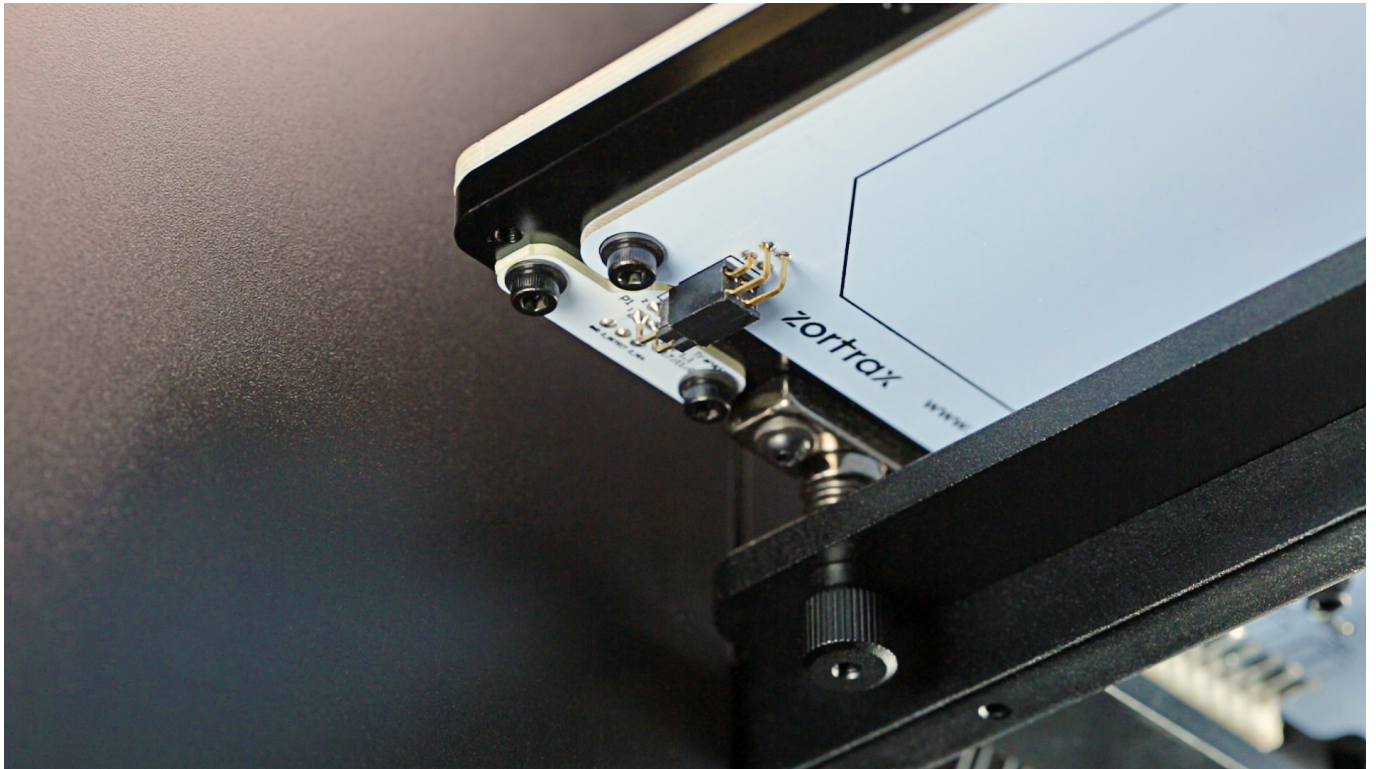
M200 PLUS

For the M200 Plus, measure the voltage between the two big pins on the connector placed under the platform and five calibration squares. The correct value is about 3.2 V.

If the voltage is lower than 3 V, carry out platform maintenance and check if the underside of the perforated plate is not damaged.

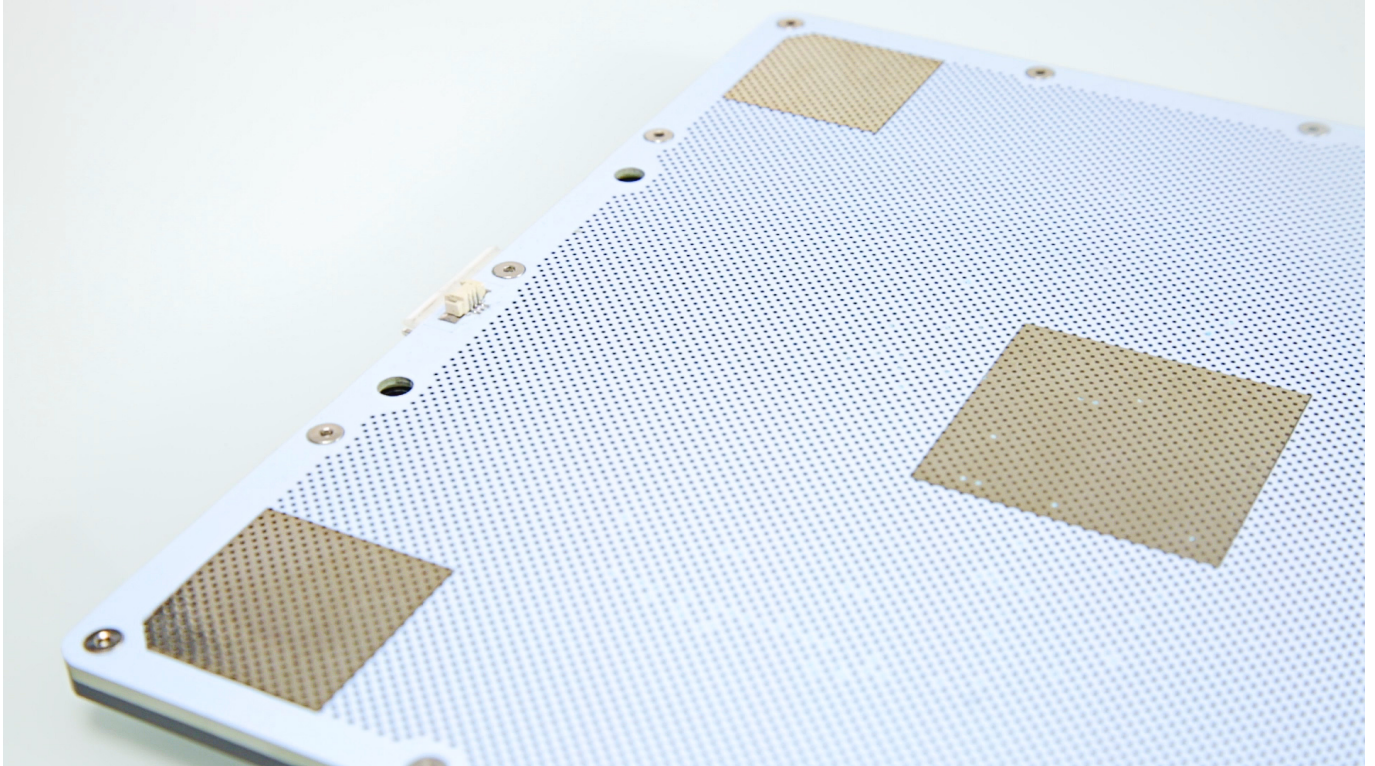
M200/M300/M300 PLUS

It is also necessary to measure the electric circuit continuity between the right pin on the plate's small connector and five calibration squares.

If the multimeter indicates that there is no circuit continuity, especially in one of the calibration squares, replace the perforated plate.

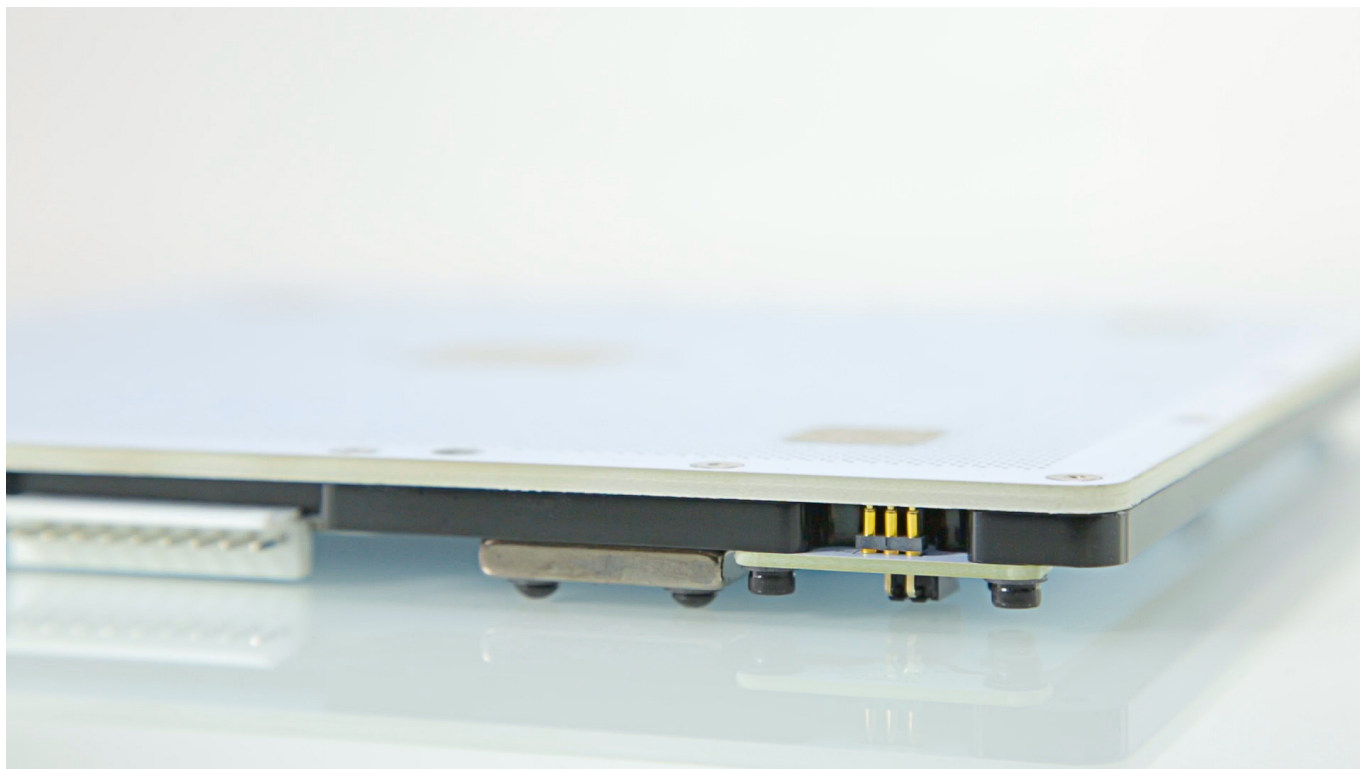
M200 PLUS

For the M200 Plus, measure the electric circuit continuity between the left pin on the plate's small connector and five calibration squares.

Before replacing the perforated plate, measure the circuit continuity between the calibration squares. If the continuity is detected, the Pogo pin is damaged.

If the multimeter indicates that there is no circuit continuity, especially in one of the calibration squares, replace the perforated plate.

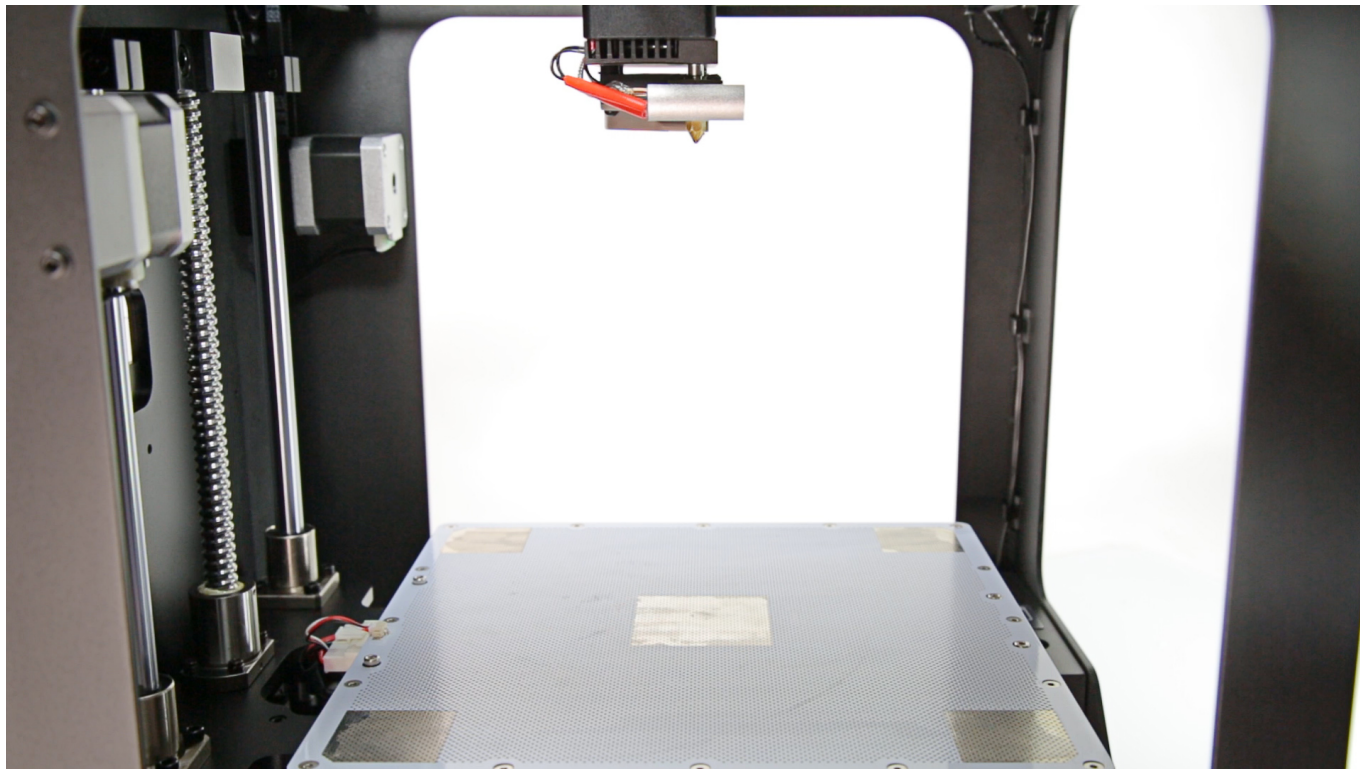
Voltage Measurements (Nozzle)

The next component that you should check is thermocouple. To do so, measure the voltage between the nozzle and five calibration squares. The correct value is about 3.2 V. If the value is correct, move on to the next step.

If the value is less than 3 V, replace the thermocouple/extruder PCB.

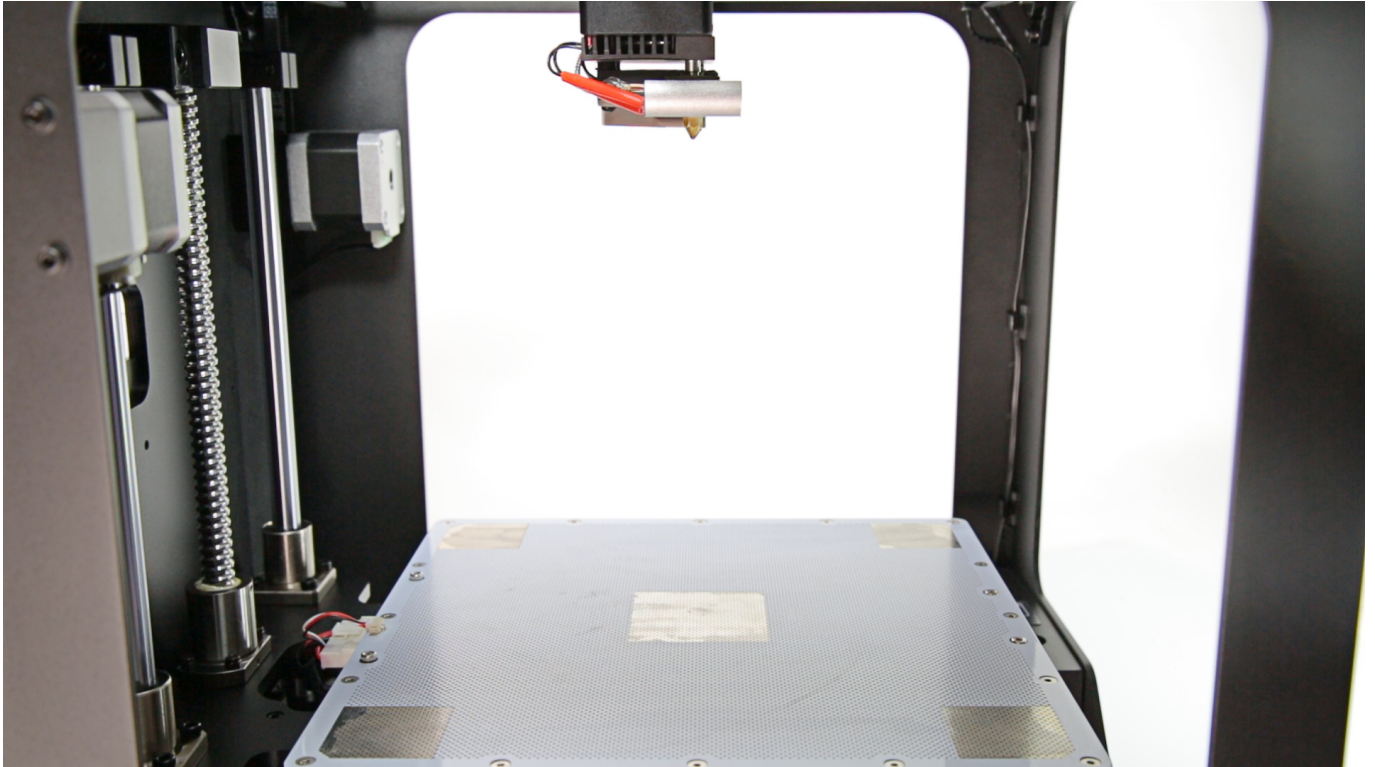
Resistance Measurements

The last step is to check the resistance between the nozzle and the thermocouple's signal cable. The correct value is 1-3 Ohm.

If you get higher or lower values, the nozzle is probably oxidized and needs to be replaced.
