Troubleshooting: Perforated Plate Hits the Nozzle

<https://support.zortrax.com/troubleshooting-perforated-plate/>

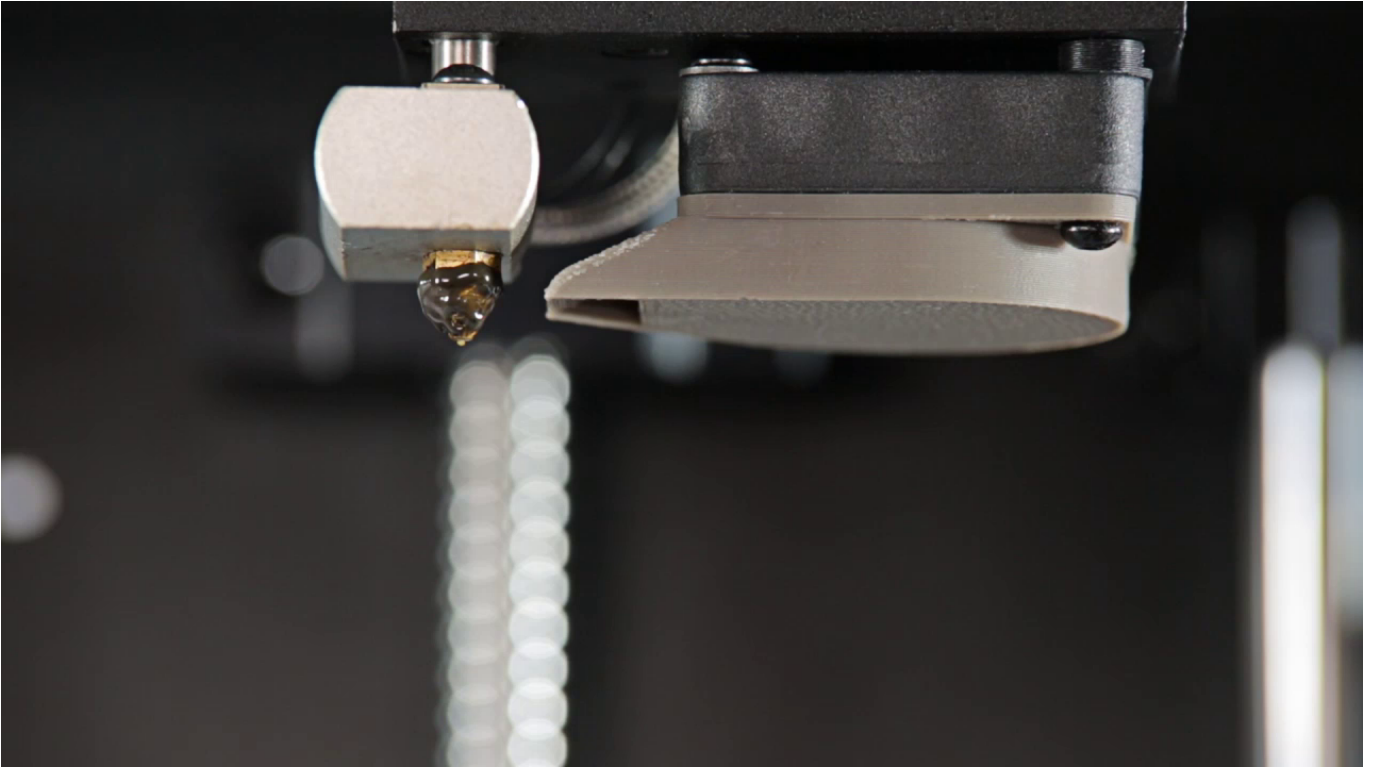
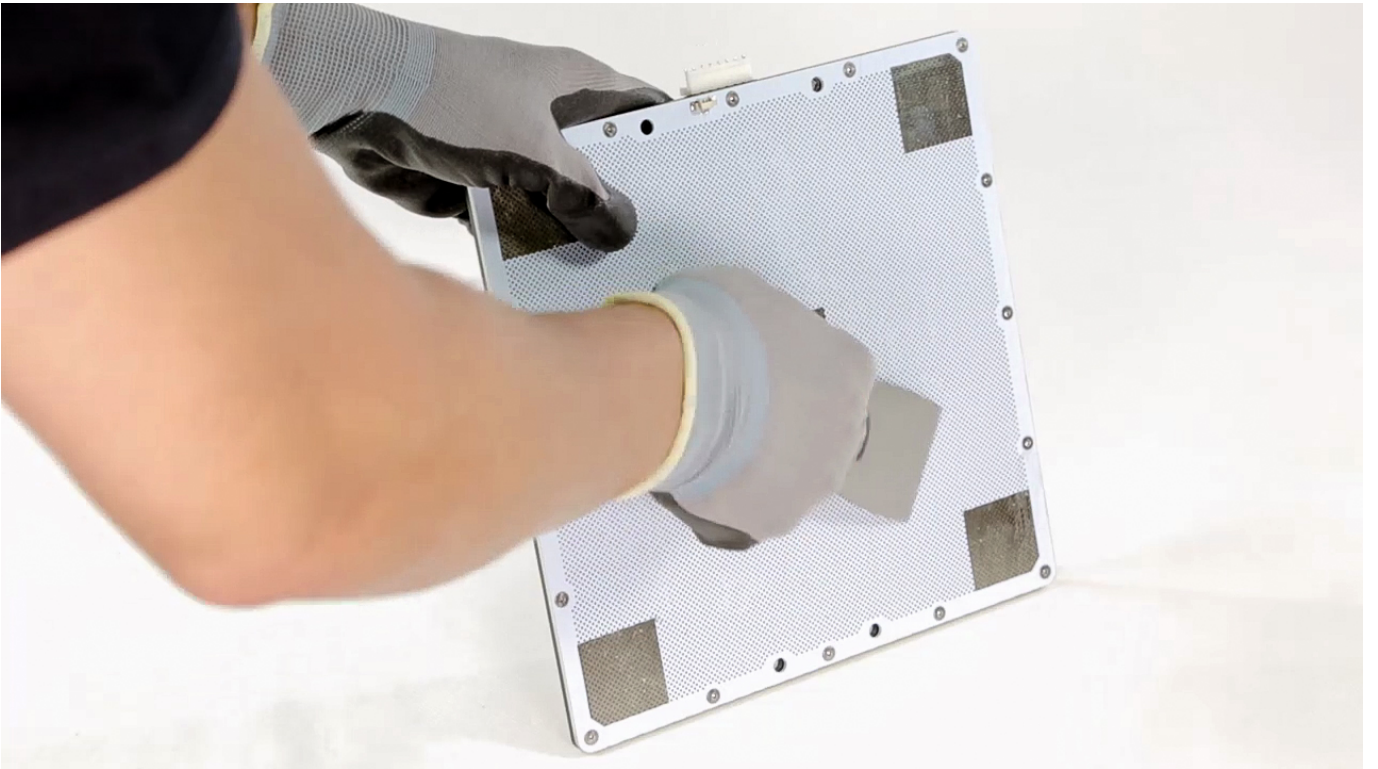
Sometimes the electrical circuit in the printer cannot be completed due to material remains on the nozzle or the perforated plate.

In this case, clean both parts with a spatula. See the manuals: [nozzle cleaning](#), [platform maintenance \[M200 Plus\]](#), [platform maintenance \[M200\]](#).
