Troubleshooting: Perforated Plate Hits the Nozzle

Perforated Plate Hits the Nozzle

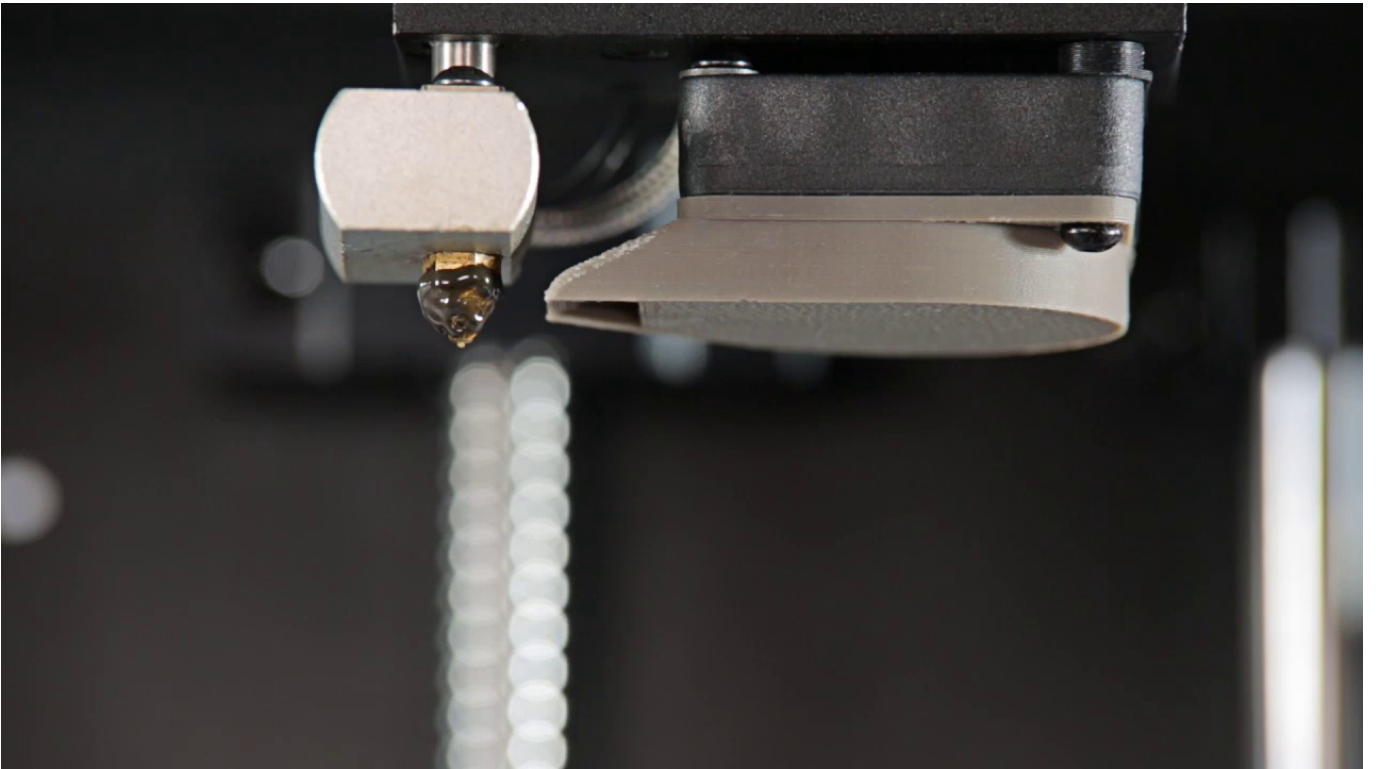
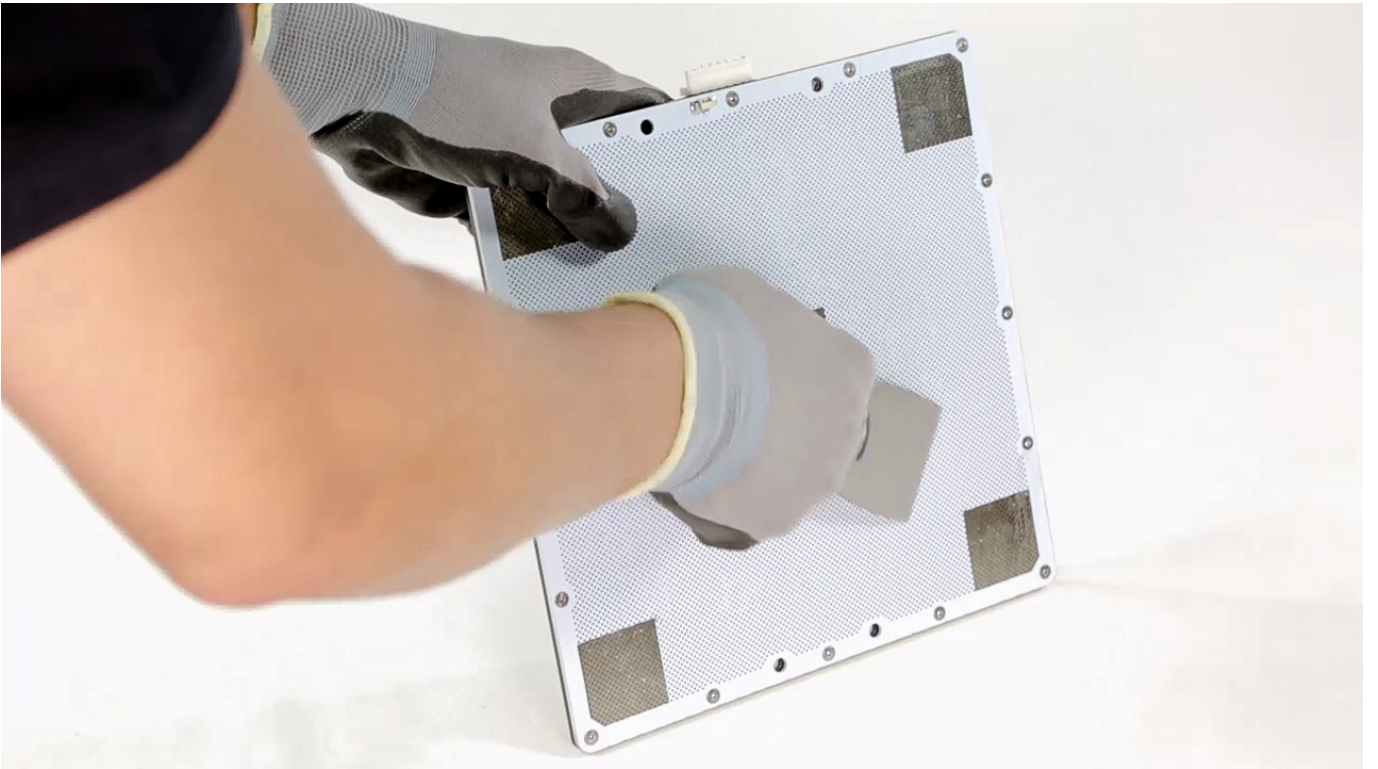
Sometimes the electrical circuit in the printer cannot be completed due to material remains on the nozzle or the perforated plate.

In this case, clean both parts with a spatula. See the manuals: [nozzle cleaning](#), [platform maintenance \[M200 Plus\]](#), [platform maintenance \[M200\]](#).

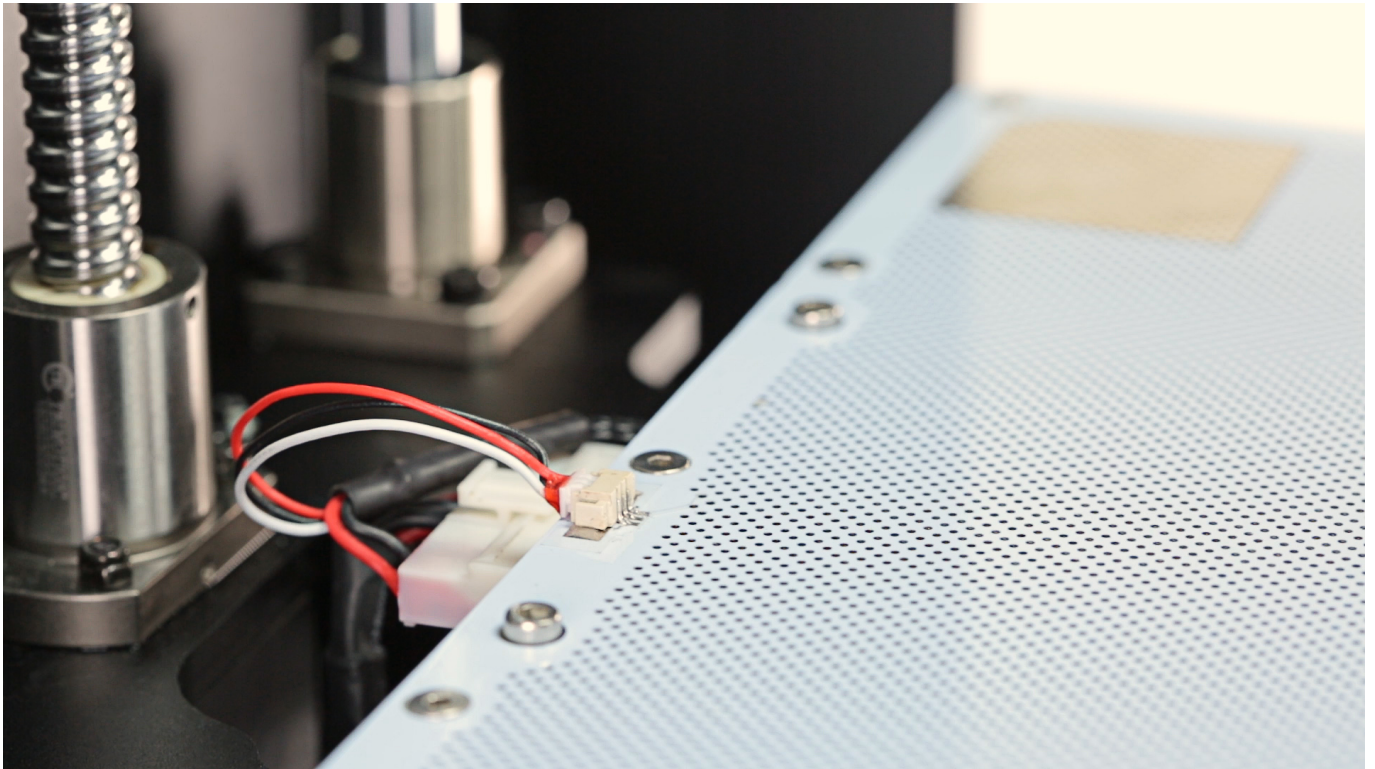
Perforated Plate Cable Connection

Make sure that the small perforated plate cable is properly connected.

If it is connected, move on to the next step.

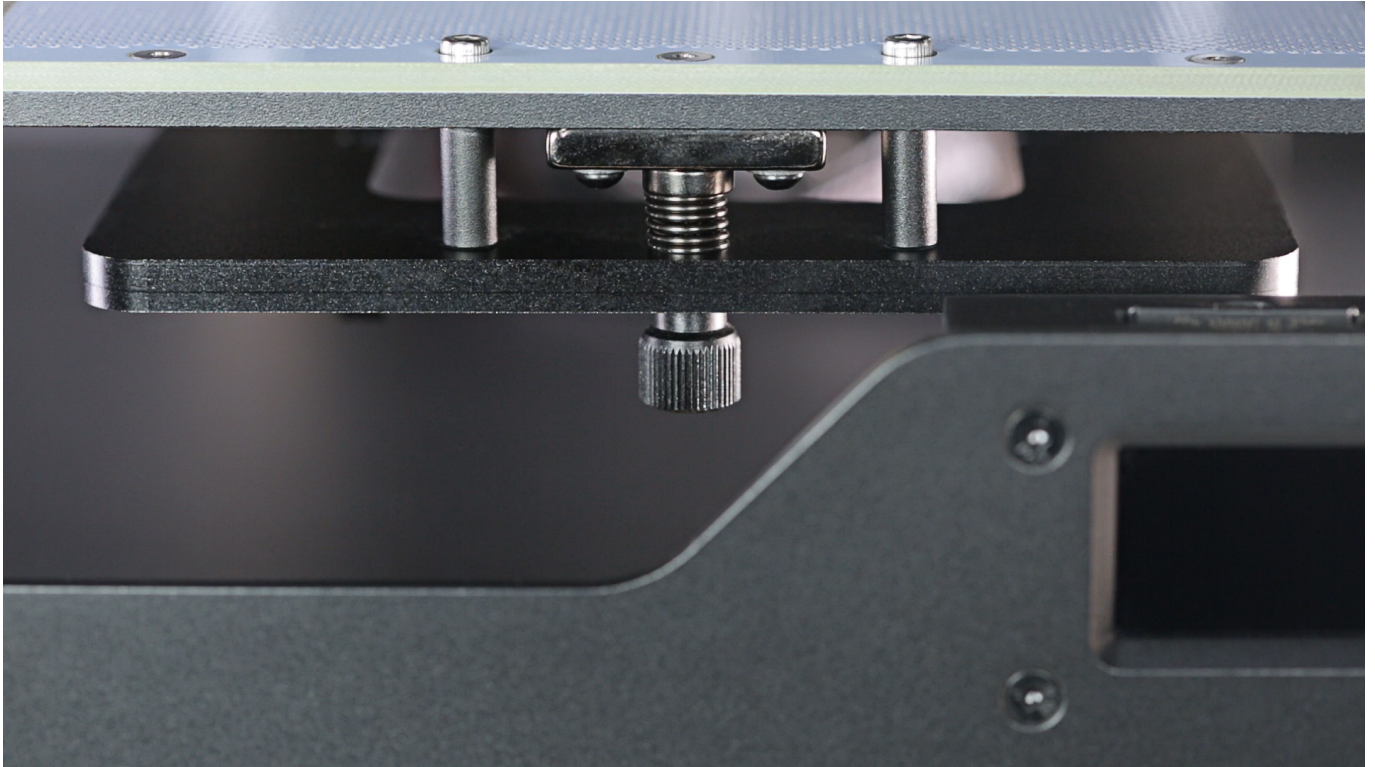
Perforated Plate and Heatbed Inspection

Now you have to determine that there is no short circuit between the perforated plate and the heatbed. Use the multimeter and check the calibration squares and the magnet/screws under the heatbed. See the video.

If the short circuit is not detected, follow the next steps provided in this manual.

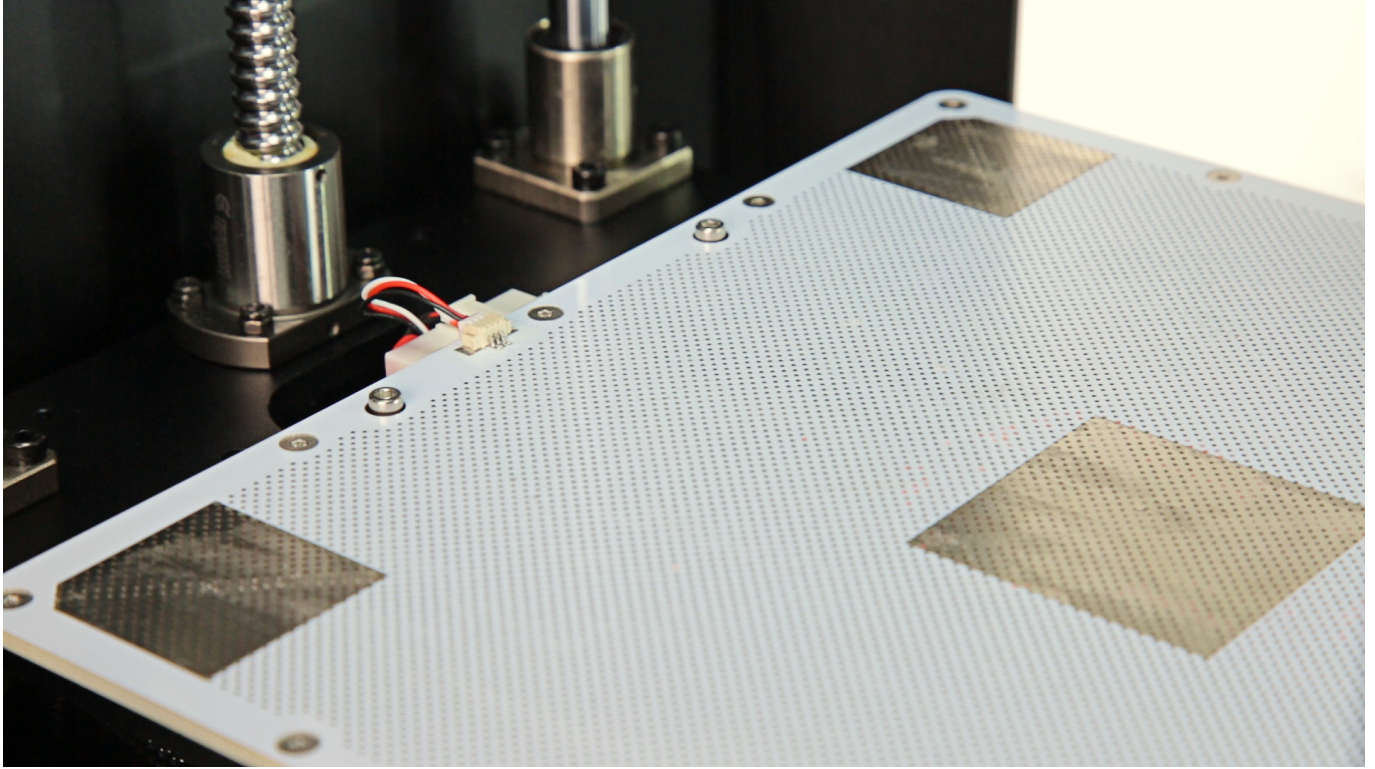
M200/M300/M300 PLUS

The next step is to check if the problem is not caused by the perforated plate. Use the multimeter and measure the voltage between the left and middle pin on the plate's small connector and five calibration squares. The correct value is about 3.2 V.

If the voltage is lower than 3 V, carry out platform maintenance and check if the underside of the perforated plate is not damaged.

Make sure that the small connector is not damaged. Otherwise, the voltage might not be properly transmitted to the calibration squares.

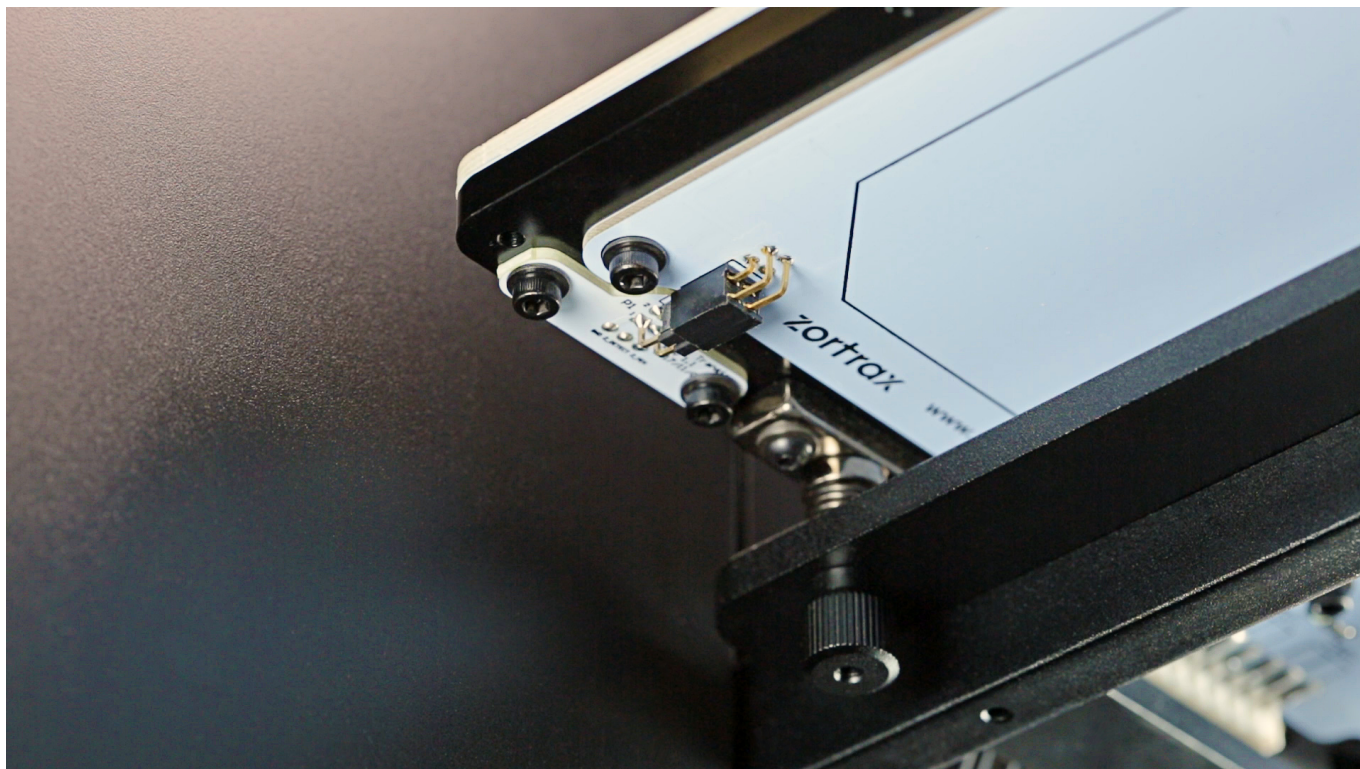
M200 PLUS

For the M200 Plus, measure the voltage between the two big pins on the connector placed under the platform and five calibration squares. The correct value is about 3.2 V.

If the voltage is lower than 3 V, carry out platform maintenance and check if the underside of the perforated plate is not damaged.

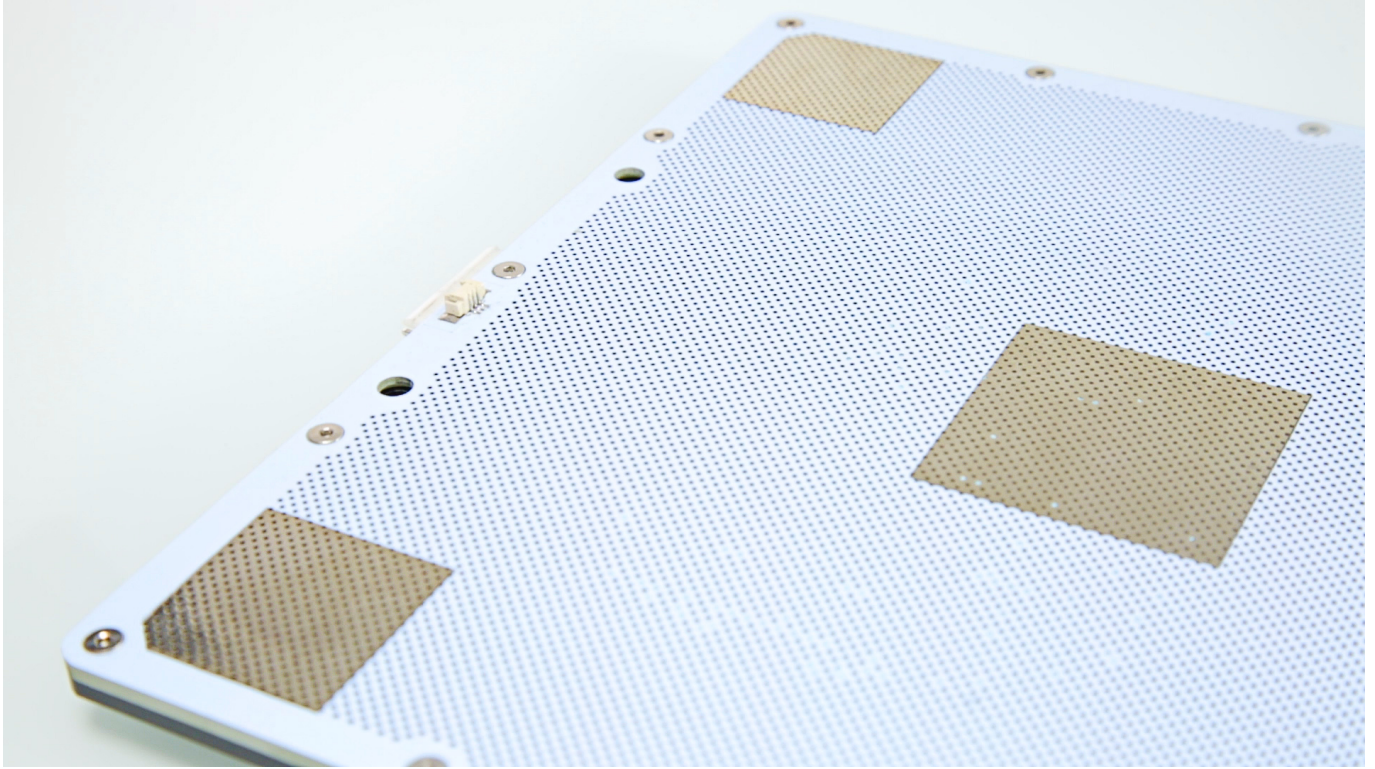
M200/M300/M300 PLUS

It is also necessary to measure the electric circuit continuity between the right pin on the plate's small connector and five calibration squares.

If the multimeter indicates that there is no circuit continuity, especially in one of the calibration squares, replace the perforated plate.

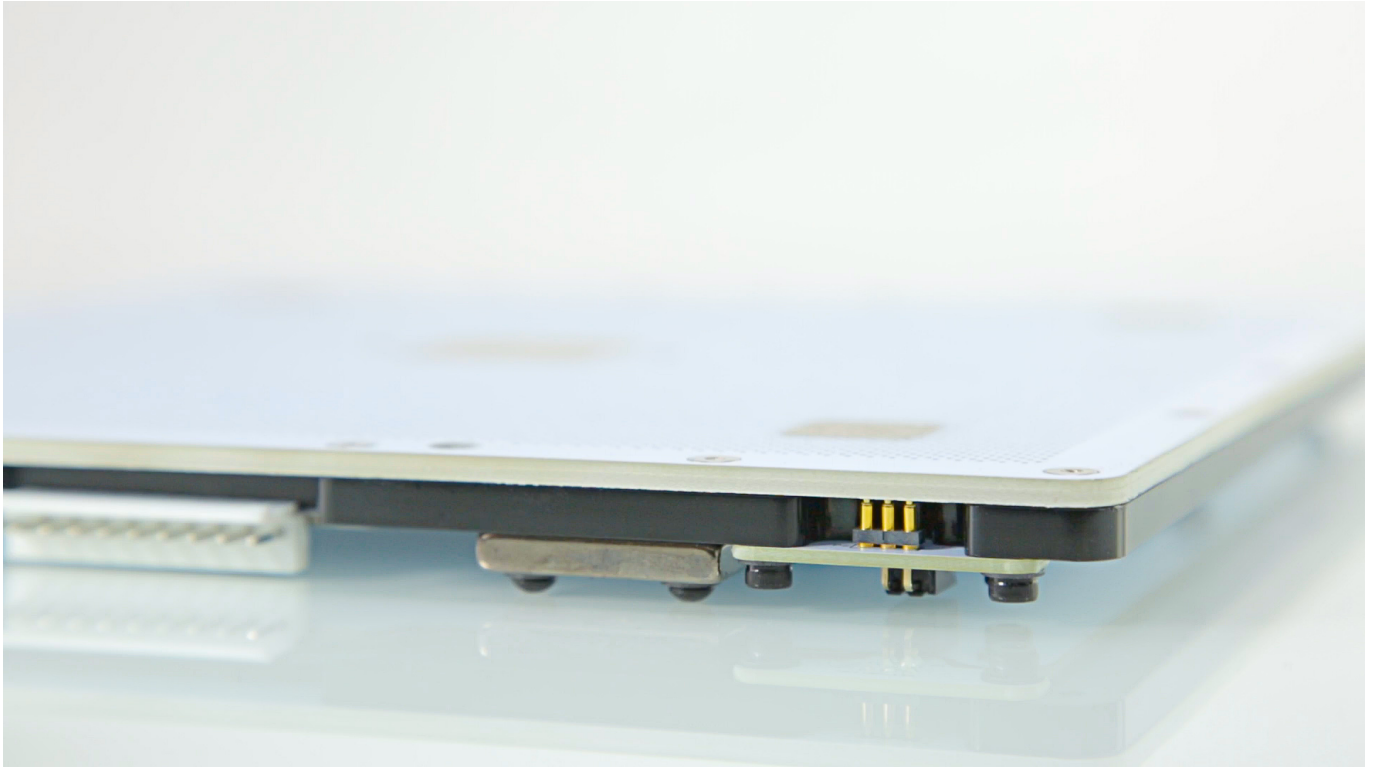
M200 PLUS

For the M200 Plus, measure the electric circuit continuity between the left pin on the plate's small connector and five calibration squares.

If the multimeter indicates that there is no circuit continuity, especially in one of the calibration squares, replace the perforated plate.

Before replacing the perforated plate, measure the circuit continuity between the calibration squares. If the continuity is detected, the Pogo pin is damaged.

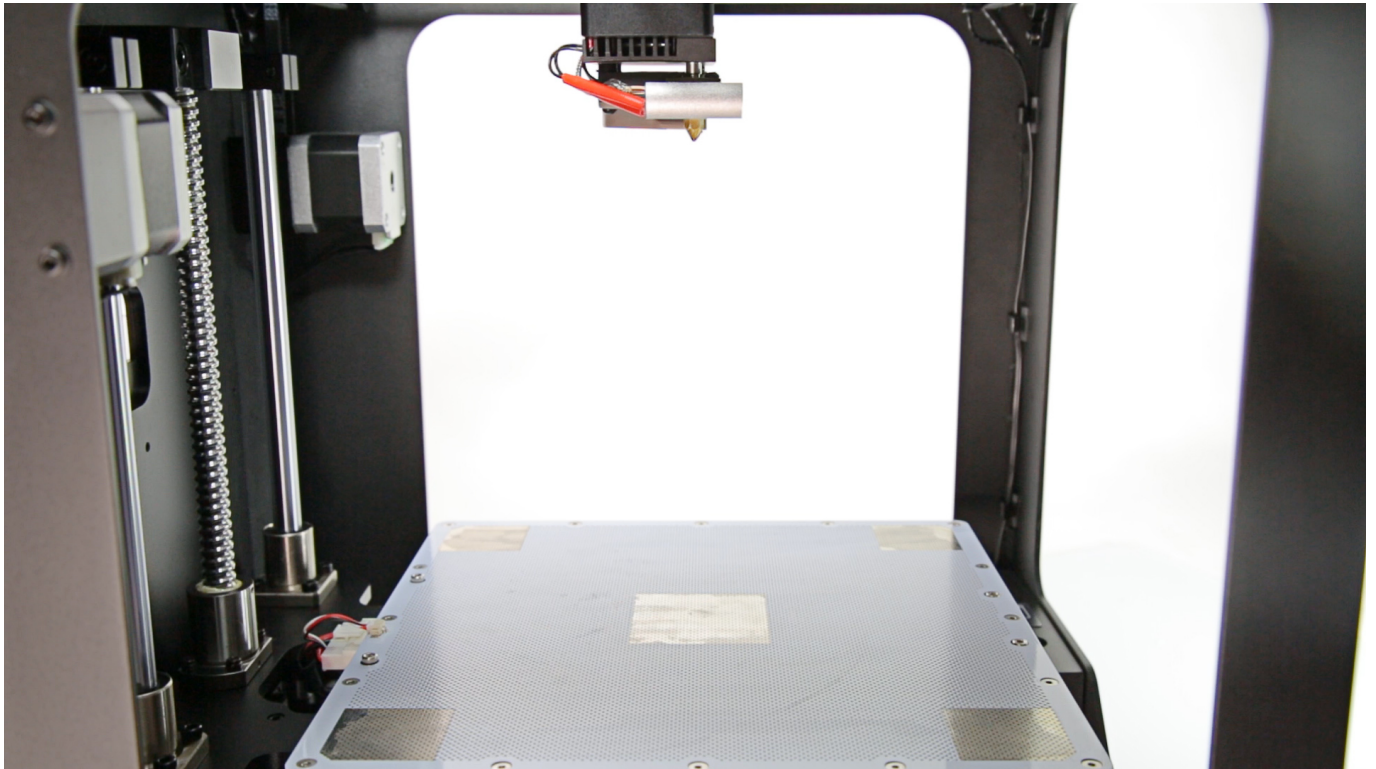
Voltage Measurements (Nozzle)

The next component that you should check is thermocouple. To do so, measure the voltage between the nozzle and five calibration squares. The correct value is about 3.2 V. If the value is correct, move on to the next step.

If the value is less than 3 V, replace the thermocouple/extruder PCB.

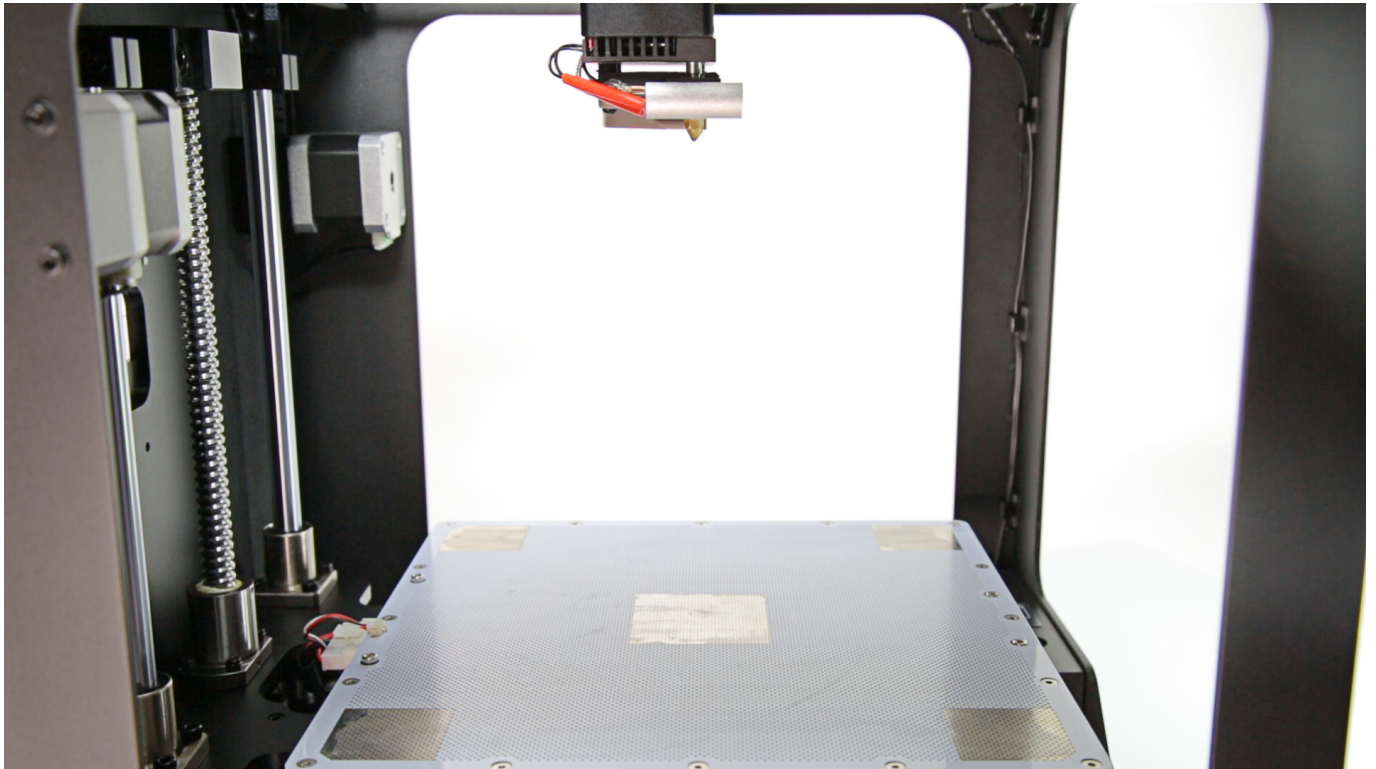
Resistance Measurements

The last step is to check the resistance between the nozzle and the thermocouple's signal cable. The correct value is 1-3 Ohm.

If you get higher or lower values, the nozzle is probably oxidized and needs to be replaced.
